**[Docket No. FAA-2005-20514; Directorate Identifier 2005-CE-08-AD; Amendment 39-14025; AD 2005-07-01]**

**Airworthiness Directives; The Cessna Aircraft Company Models C208 and C208B Airplanes**

#### **Airworthiness Directives; the Cessna Aircraft Company Models 208 and 208B Airplanes**

#### **Airworthiness Directives; The Cessna Aircraft Company Models 208 and 208B Airplanes**

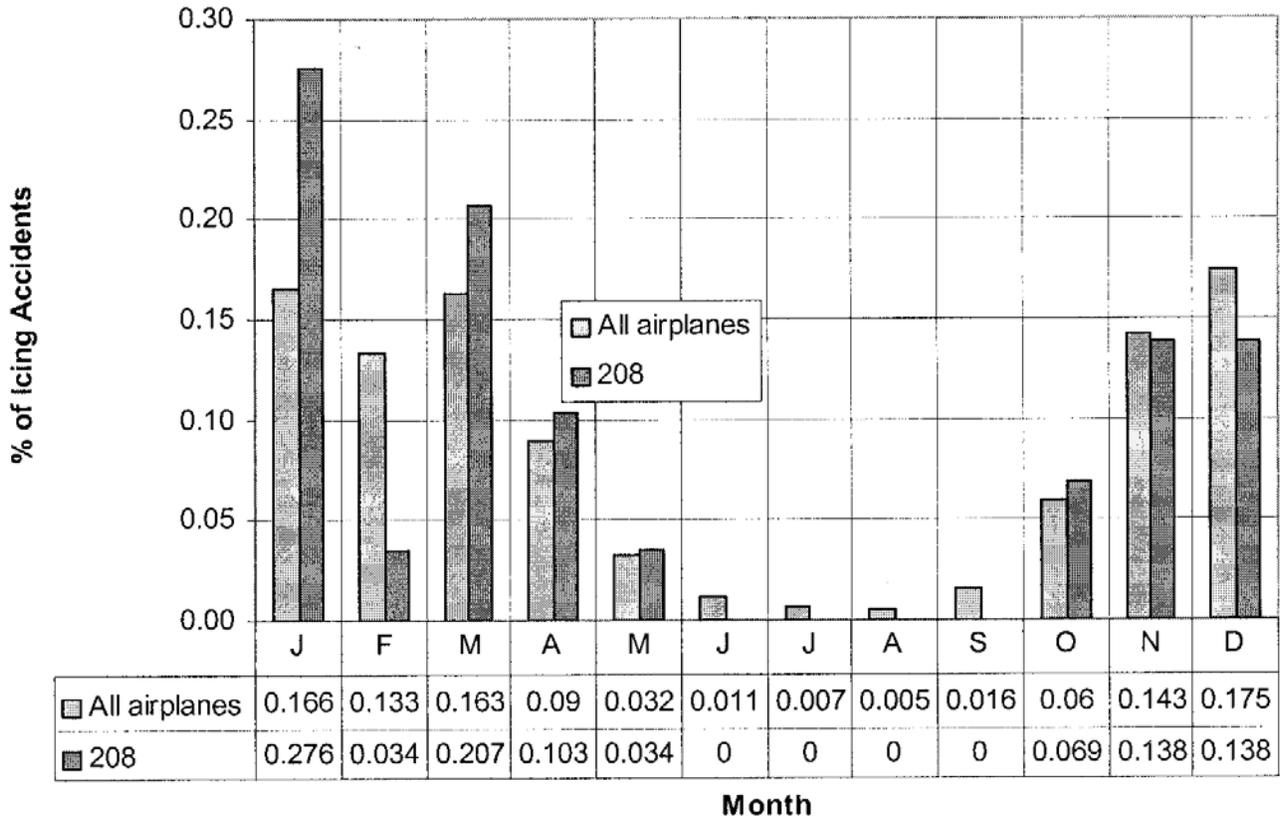
**U.S. Icing Accidents per Month since 1983**

*What events have caused this AD?* The FAA has received several reports of accidents/incidents concerning problems with Cessna Models 208 and 208B airplanes during operations in icing conditions. This includes a total of six accidents in the previous two icing seasons and nine events in the past few months. Most of the accidents occur on approach and landing. One-third are suspected to be in supercooled large droplets, icing conditions outside the 14 CFR part 25 Appendix C certification envelope. The Cessna Models 208 and 208B are certificated to 14 CFR part 23, but 14 CFR part 23 references 14 CFR part 25 Appendix C for icing certification. The following chart shows the monthly breakdown of the icing accidents/incidents of the affected airplanes:

The information shows that icing accidents/incidents are just as prevalent or more prevalent during the months of March and April than in November, December, and January. Therefore, the next month is critical for the continued operational safety of the Cessna Models 208 and 208B in icing conditions.
